## Introduction

### Prepainted Metallic-Coated Steel Sheet

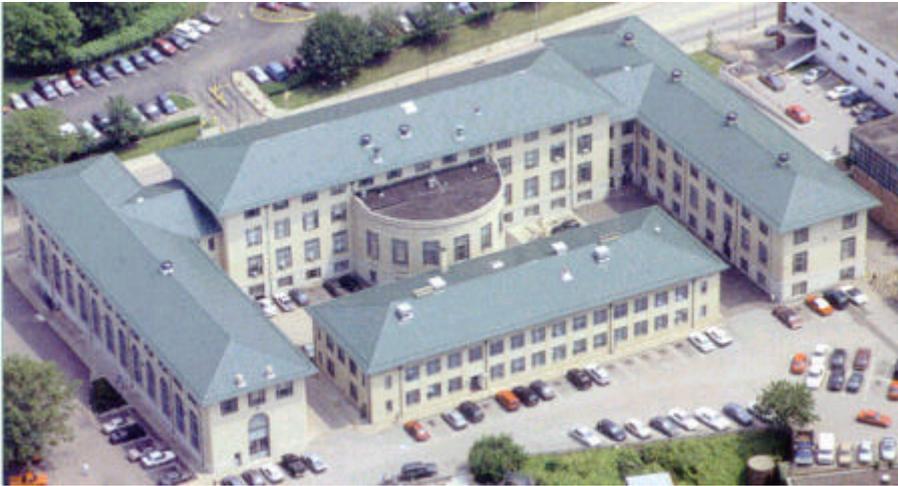
Source: [www.mbma.com](http://www.mbma.com)

Prepainted metallic-coated steel sheet for buildings has been used very successfully for many years. One indicator of the popularity of this product is the large number of roofs made with prepainted steel in place around North America and other parts of the world. An example of one such application is shown in the photograph below and illustrates how this material can be used in a striking and effective manner.
